News from the Dam Safety Program

October 2004 Volume 3, Number 5

Failure of Upper Carter Pond

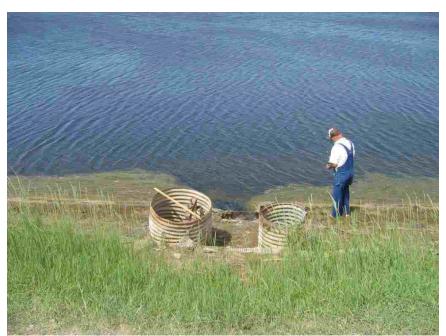
Sterling was notified on July 13, 2004 that there was a problem with the Upper Carter Pond. This is a privately owned pond with a DFWP sponsored access site for fishing. The dam is 21 feet high, storage is about 144 AF and drainage area is 2.5 square miles. A failure had occurred within the past week or two and the majority of water in the pond had drained out. Apparently a hole developed in the riser pipe (cmp) and fill material piped through the hole creating a small void on the upstream face. There appeared to be no immediate safety threat as the remainder of the structure seemed stable and no water was moving along the outside of the conduit.

Control tower to left and principle riser to right. The void is beyond and between the two riser pipes.

The US F&WS and Ducks Unlimited have become involved and there is an excellent chance they will help provide funding for rehabilitation of this dam and Lower Carter Pond as well. They expect work to be completed by next fall.
